**TMS320C6711, TMS320C6711B,  
TMS320C6711C, TMS320C6711D**  
**Digital Signal Processors**  
**Silicon Errata**

**C6711 Silicon Revisions 1.0, 1.2, and 1.3**

*SPRZ1730*  
May 2000  
Revised April 2005

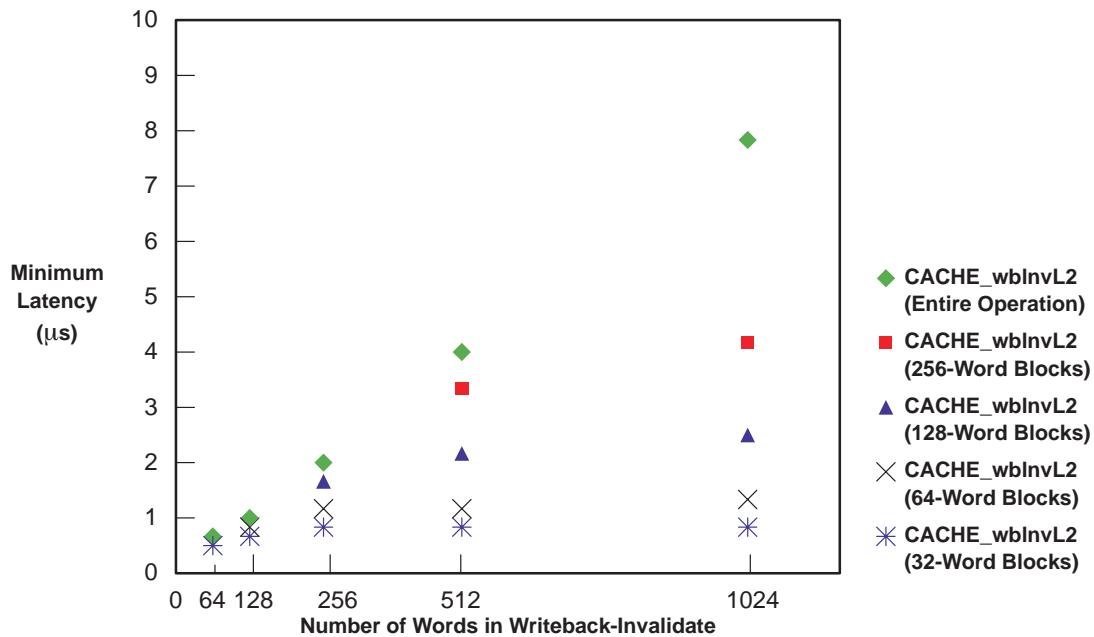
**Figure 2. Minimum Required Latency Between McBSP Events for a Successful Transfer with Concurrent L2 Writeback-Invalidates at 200-MHz CPU and 50-MHz EMIF, Using Entire Operations and Block Breakdown**

If the EMIF frequency is more than half of the CPU frequency, the device is able to service the L2 writeback requests faster than the requests can be issued, leaving some EMIF bandwidth available to service other EDMA requests, so the block-out problem is less noticeable. Therefore, breaking down cache operations into smaller blocks is more critical when the EMIF frequency is less than half of the CPU frequency. Figure 2 shows the minimum required latency between McBSP transfers to EMIF at 200-MHz CPU and 50-MHz EMIF when breaking down the cache operations. These McBSP transfers were performed with concurrent cache operations to EMIF, creating a block-out scenario. With the 1024-word cache writeback-invalidate operation broken into 32-word blocks, the McBSP is able to perform almost 10 times faster. The performance improvement is similar when breaking down the writeback-only operation.

For example, if the CPU is running at 200 MHz with a 50-MHz EMIF and you have a McBSP hard real-time deadline of 5 µs, Figure 2 shows that a 1024-word L2 writeback-invalidate may cause data loss since back-to-back McBSP events can only be serviced at ~8 µs. By breaking down the L2 writeback-invalidate into 256-word blocks, you can then meet the 5-µs McBSP deadline. In other words, when performing a 1024-word L2 writeback-invalidate operation with the CPU and EMIF conditions cited above, the McBSP events can be serviced in ~8 µs for the entire operation (one whole block), in ~4 µs when breaking it into 256-word blocks, in ~2.5 µs when breaking it into 128-word blocks, etc.

To avoid cache operations blocking other time-sensitive EDMA accesses, observe the following guidelines:

1. Avoid placing real-time data in EMIF address range. Instead, real-time data should be placed in the L2 address range.
2. If data must be placed in the EMIF address range:
  - Avoid global cache operations in favor of block-based cache operations.
  - Block-based cache operations should be submitted in small blocks, such that the total amount of time that the EMIF is blocked is less than the amount of time between serial samples.

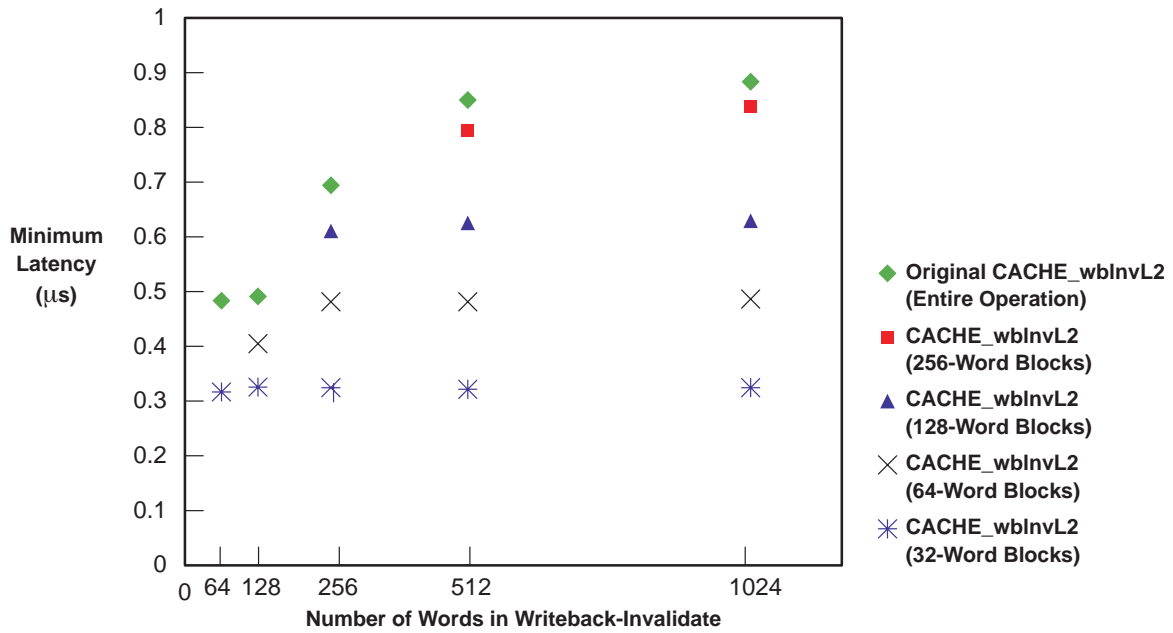
**Figure 3. Minimum Required Latency Between McBSP Events for a Successful Transfer With Concurrent Writeback-Invalidates at 225-MHz CPU and 100-MHz EMIF, Using Entire Operations and Block Breakdown**

When the CPU is set to 225 MHz and the EMIF is set to 100 MHz, breaking down the cache operations will still improve the block-out problem. Figure 3 shows the improvement in the McBSP's performance with this frequency ratio.

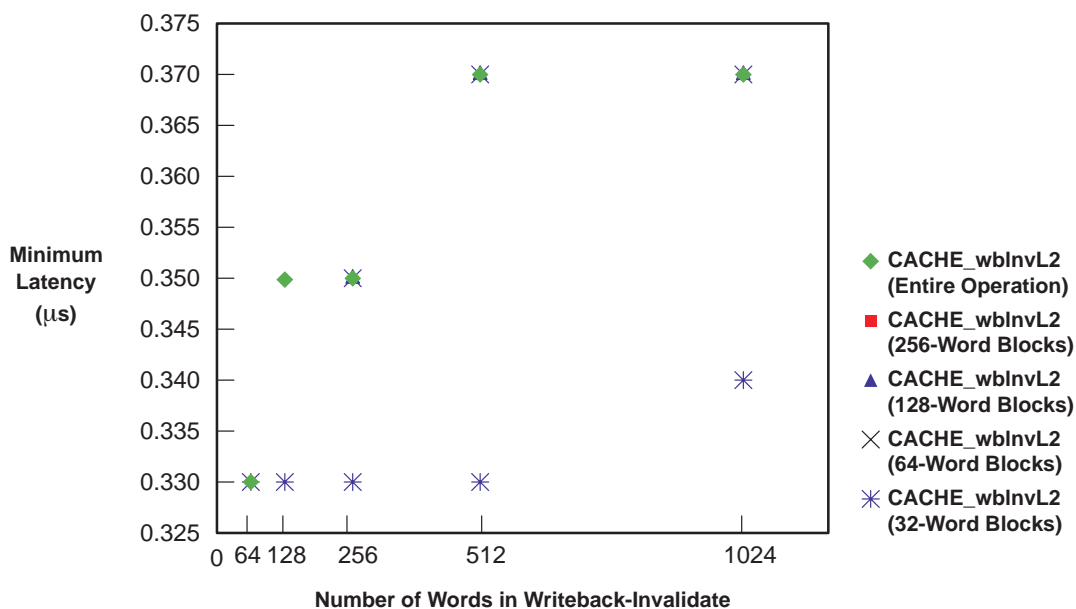
**Figure 4. Minimum Required Latency Between McBSP Events for a Successful Transfer With Concurrent Writeback-Invalidates at 150-MHz CPU and 100-MHz EMIF, Using Entire Operations and Block Breakdown**

When the CPU is set to 150 MHz and the EMIF is set to 100 MHz, there is virtually no benefit from breaking down the coherency cache operations. Figure 4 shows the McBSP’s performance with this frequency ratio.

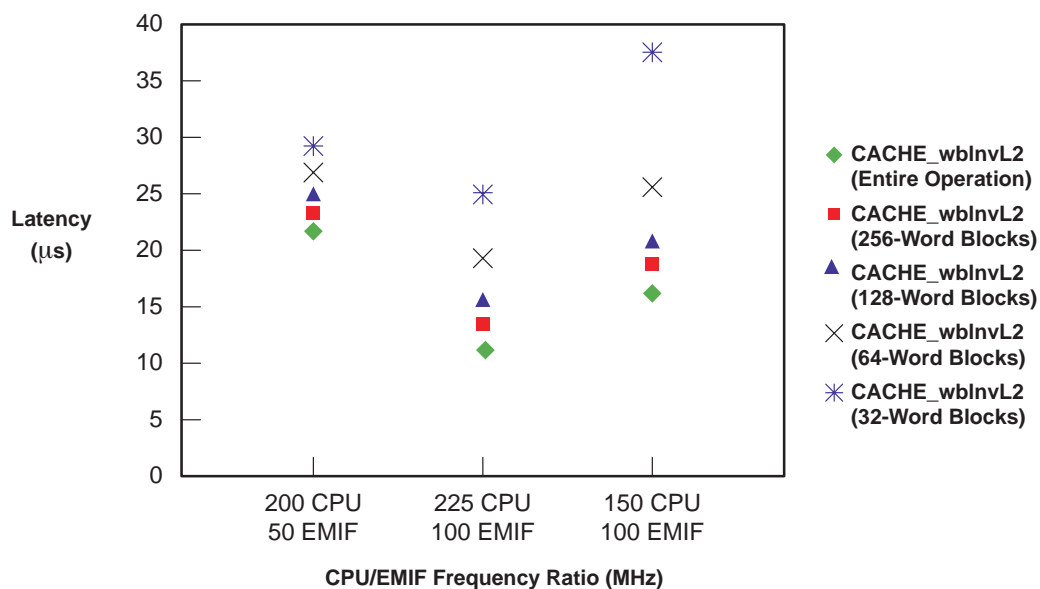
**Figure 5. 1024-Word L2 Writeback-Invalidate Performance at Various Frequency Ratios With Old and New CACHE-wbInvL2()**

Breaking down the cache operations into smaller blocks takes longer to complete than performing the entire cache function as one large block. Figure 5 shows how much extra overhead is incurred by breaking down an L2 writeback-invalidate operation to transfer 1024 words with different sized blocks and at various frequency ratios. Notice that for the 200-MHz CPU and the 50-MHz EMIF frequency ratio, where the new functions are most critical for peripherals such as the McBSP, the least overhead is incurred.

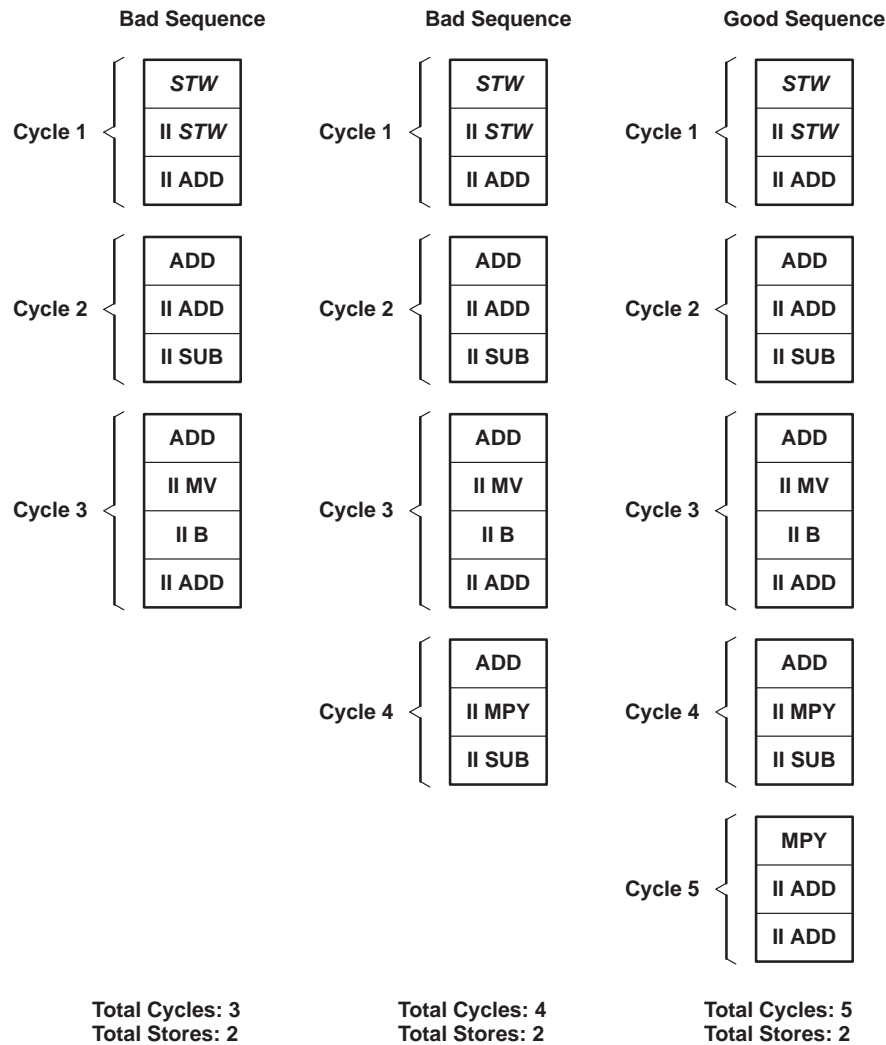
Figure 7. Pseudo Code Example With Parallel Stores (Criteria 2)

Figure 7 outlines this scenario. Note that the STW instruction represents a store of any word size (32-, 16-, or 8-bit).

In most looped code, more than one instruction would likely be executed on each cycle, i.e., instructions would be executed in parallel. In this case, as long as a store is one of the instructions being executed in parallel on a particular cycle, that cycle counts as a cycle on which a store occurs. Instructions with parallel bars (||) at the beginning of the line of assembly execute in parallel with instructions on the preceding line.

- A. Reduce the duration of the loop by breaking into smaller loops. If a particular problem loop has a length of 4 cycles (determined by looking at the software pipeline kernel in the assembly file), and the loop runs 200 times, then the total loop duration is ~800 cycles. If the deadline is 586 cycles, then loop could cause a problem (assuming the loop meets all the other criteria). The workaround is to break the loop into four smaller loops of 50 iterations each. Then any one loop will only run for 200 cycles allowing the EDMA transfer to complete between the smaller loops.

- B. Try to break criteria 2. The quickest way to do this is to turn off optimization for the file containing the problem loop (this is done in the File Specific Options for the file). Instead of using the compiler switch `-o3`, use the compiler switch `-o1` for the particular problem file. This will cause the problem loop to not be software pipelined and less likely to meet criteria 2. The downside to this fix is that all the loops in the particular file will be un-optimized, not just the problem loop.

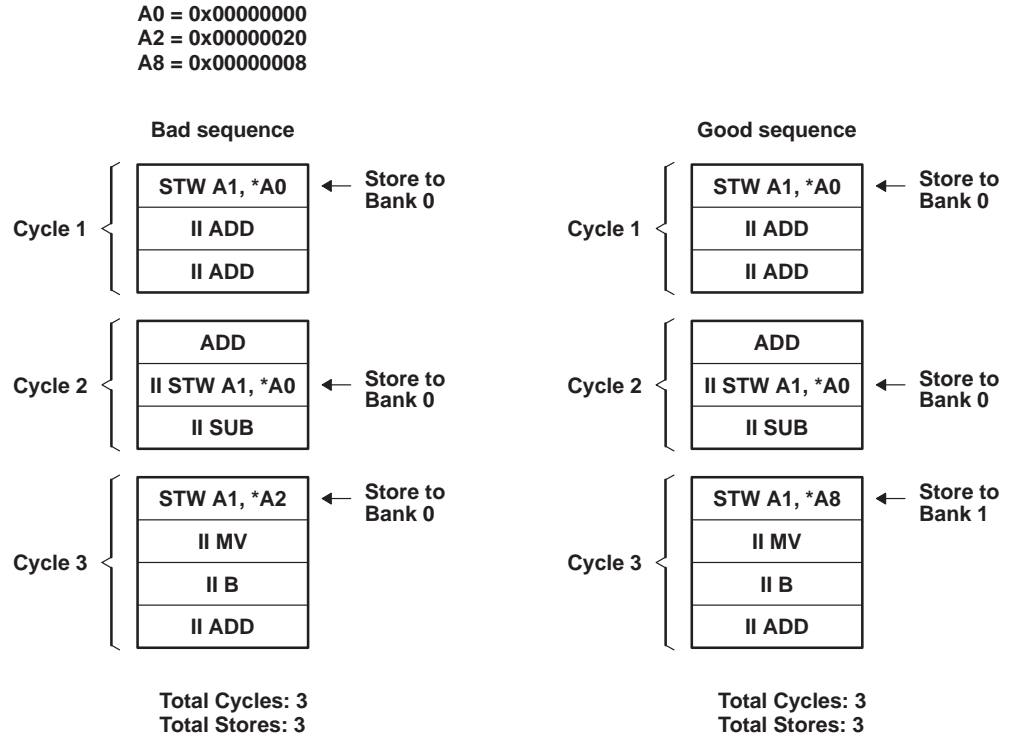
**Figure 8. Pseudo Code Example Stores to Specified Banks (Criteria 3)**

- All stores in the loop must be to the same bank of L2. If there are any stores to another bank, this will free the first bank long enough for the EDMA access to get in (see Figure 8).

In the case of two stores occurring on the same cycle, in parallel, the same rules apply. If both stores are to the same bank (and there are no other stores in the sequence to a different bank), then a problem may occur. If each of the parallel stores is to a different bank, then the problem cannot occur.

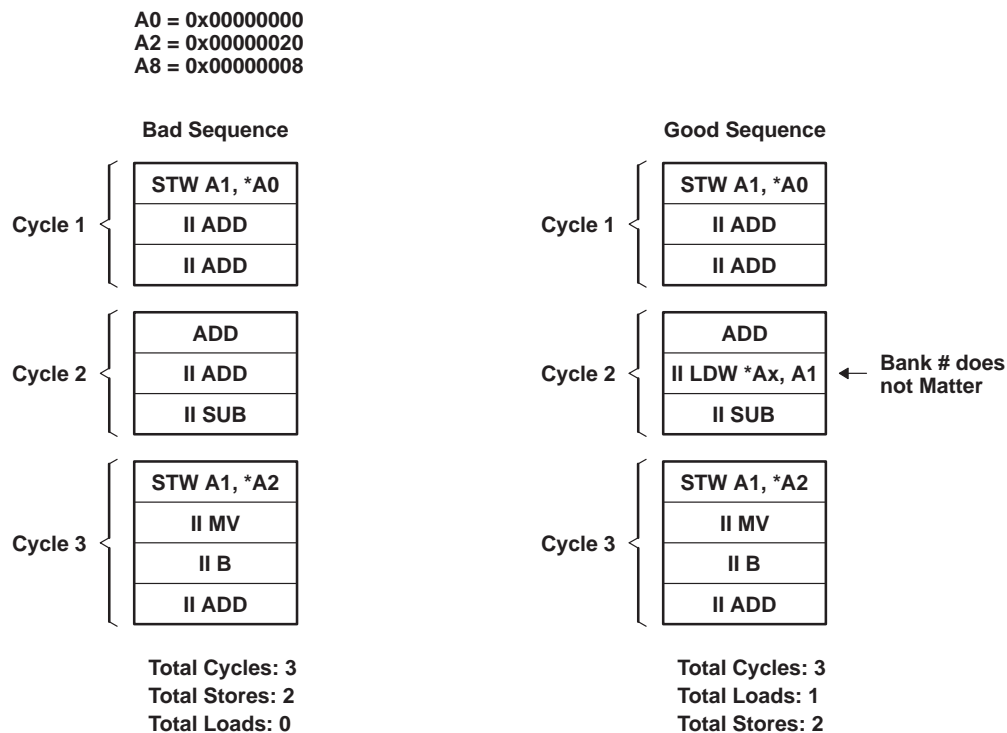
Figure 9. Pseudo Code Example Stores and Loads (Criteria 4)

A load from L2 provides enough of a gap to allow the EDMA to access L2. The good sequence would not cause a problem even if the load were executed in parallel with one of the stores, as long as the load occurred somewhere in the sequence. Notice that although the good sequence satisfies criteria 2 and 3, it would not cause a problem.

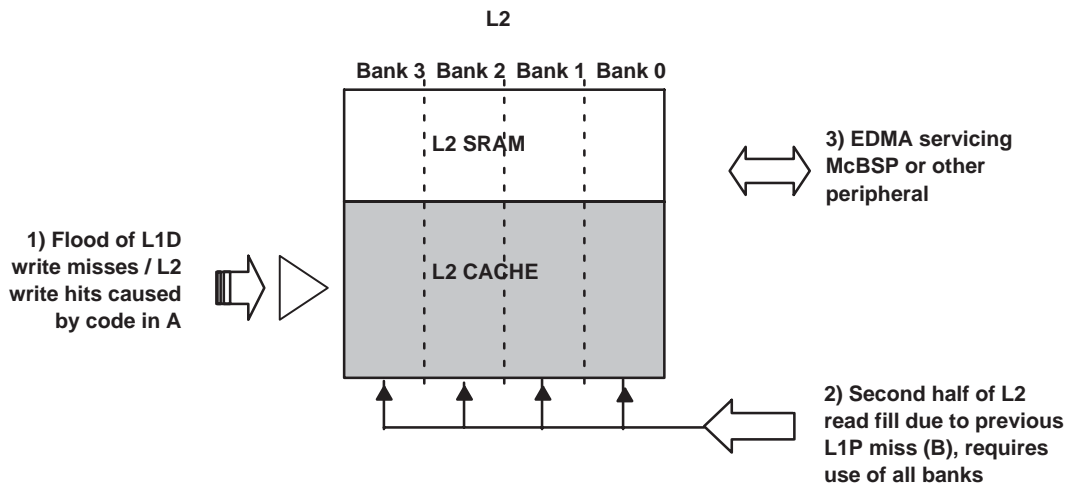
Figure 10. Problem Scenario

In this scenario, the next CPU fetch packet does not reside in either L1P or L2 cache; therefore, it causes an L1P and L2 miss. An L2 cache line (128 bytes, 4 fetch packets) must be fetched from external memory. The fetch from external memory is split into two requests (two halves) of 64 bytes, or two fetch packets each. In this document, the two halves are labeled A and B, respectively, as shown in Figure 10. The first half (A) to arrive in L2 is the half in which the missed fetch packet resides. This first half is immediately forwarded to L1P so that CPU can resume execution before the second half (B) is fetched from external memory. The second half of the L2 line (B) is to be fetched and written to L2 later.

The lockout condition occurs only when the second half (B) of the L2 cache line fill starts. When the B is ready, it attempts to write to L2. It will be unable to do so, however, because the line fill operation accesses all four banks of L2 whereas one bank is always busy servicing the higher priority L1D misses from the code in A. Thus, the line fill (B) cannot complete until the flood of writes from A has stopped. The line fill stays at the head of queue in the EDMA controller, so any other EDMA transfers that access L2 will also be blocked until the flood of stores has stopped *and* the L2 line fill (B) has completed.

The amount of time that an EDMA transfer is locked out of L2 is determined by the code running on the DSP (A), and ultimately by the amount of time that L1D write misses are happening in succession. When all of the conditions are met, the second half of the L2 line fill and the EDMA will be locked out of L2 as long as the flood of stores is sustained.

- Avoid the flood of L1D write misses. Pre-read all data locations prior to writing them. This will allocate them in L1D, preventing the L1D write misses from occurring. Recall that L1D read misses do not cause problems.
- Make sure that any algorithm or code segment that naturally produces a long string of writes inserts gaps in the write sequence such that writes occur at a frequency slower than 1 write miss every other cycle. The term "long" is based on the system requirements. Gaps in the L1D write misses means that the second half of the L2 read fill is given a chance to access L2.

- Run the algorithm or code segment that contains A from internal SRAM. There will not be L2 code read fill (A or B) coming into L2. The simulator can be used to detect such code segment. See simulator section below for details.
- Ensure the problematic segment of algorithm or code is in cache. This can be accomplished by issuing any CPU read/load instruction from the beginning of the problematic code segment in external memory, that will cause both L1D and L2 miss. Assuming the code segment is not yet in L1/L2 cache, Performing CPU load instruction generates an L1D request, and CPU stalls until the code missed and data is returned from L2. After the load instruction, code segment will reside in the L2 cache, and an L2 read fill due to L1P miss will not occur.

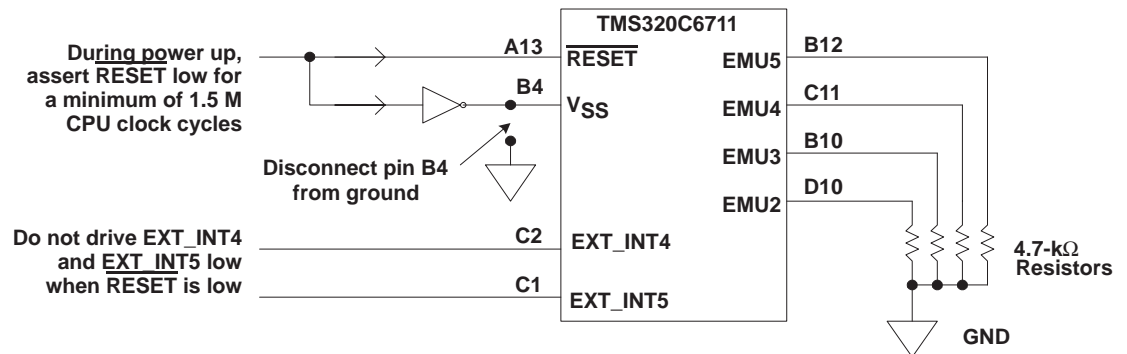
**Figure 11. Board Modification****2. Test Code**

**Details:** On TMS320C6711 devices, certain test logic associated with the L1D controller may power up initialized to an incorrect state. In this case, any of the following conditions will cause data corruption:

The data at the address pointed to by the current load or store operation will be corrupted with the last value present on the associated store data bus. Although infrequent, stalls can have a variety of causes, such as: program-cache miss, data-cache miss, and data-cache store buffer stall. Thus, there is no viable software workaround.

- While  $\overline{\text{RESET}}$  is active low, inputs EXT\_INT4 and EXT\_INT5 should be high to allow the test mode to run to completion. Both pins include internal pullups, so undriven inputs will meet this requirement.
